A PRACTICAL PROBLEM
IN FACTORY BUILDING ²²⁰³₁₉₂₀
DESIGN AND CONSTRUCTION

A THESIS

RAYMOND J. KOCH

MAY 27, 1920

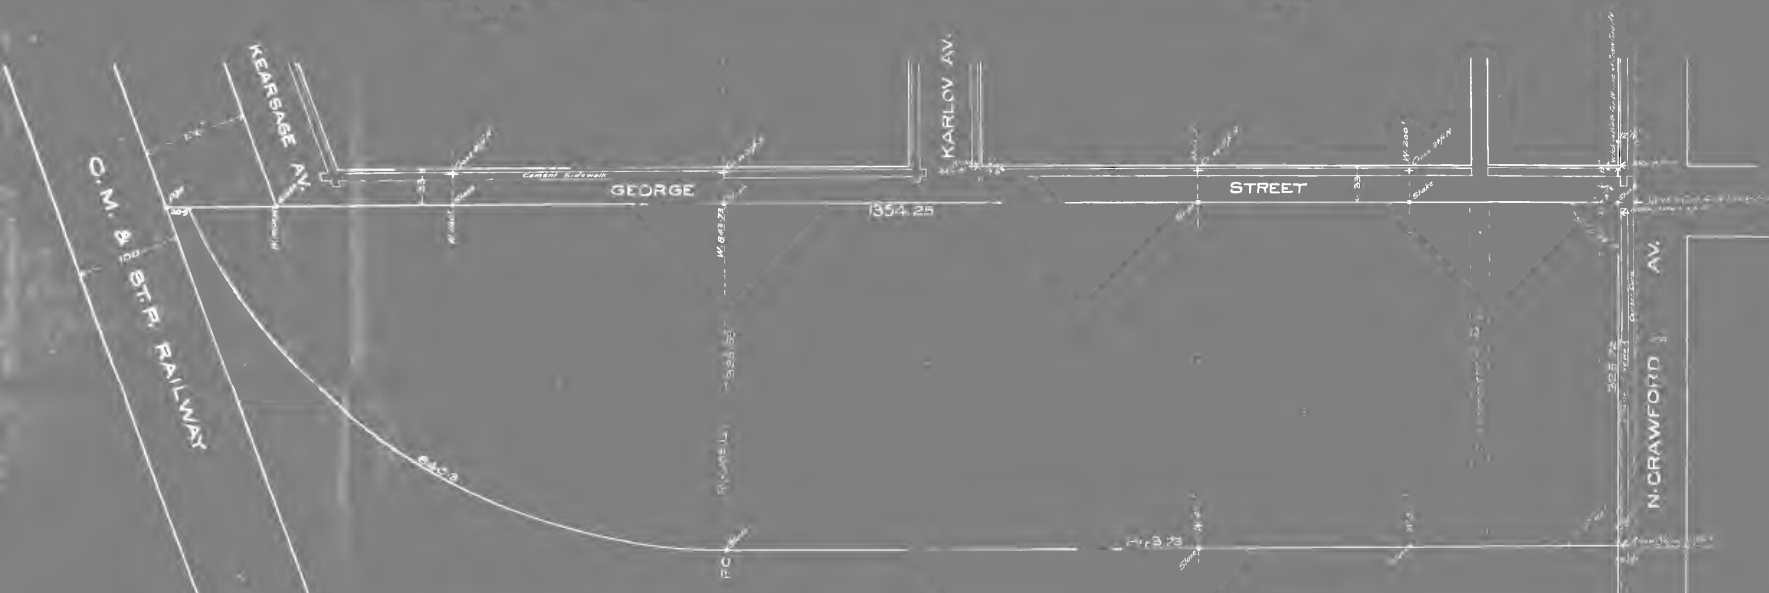
PLAT OF SURVEY

The following described tract of land with 1/2 of the ... and described as follows:
 Beginning at a point on the W line of N Crawford Av. 340.78' ...
 ... and ending at the same place of beginning.

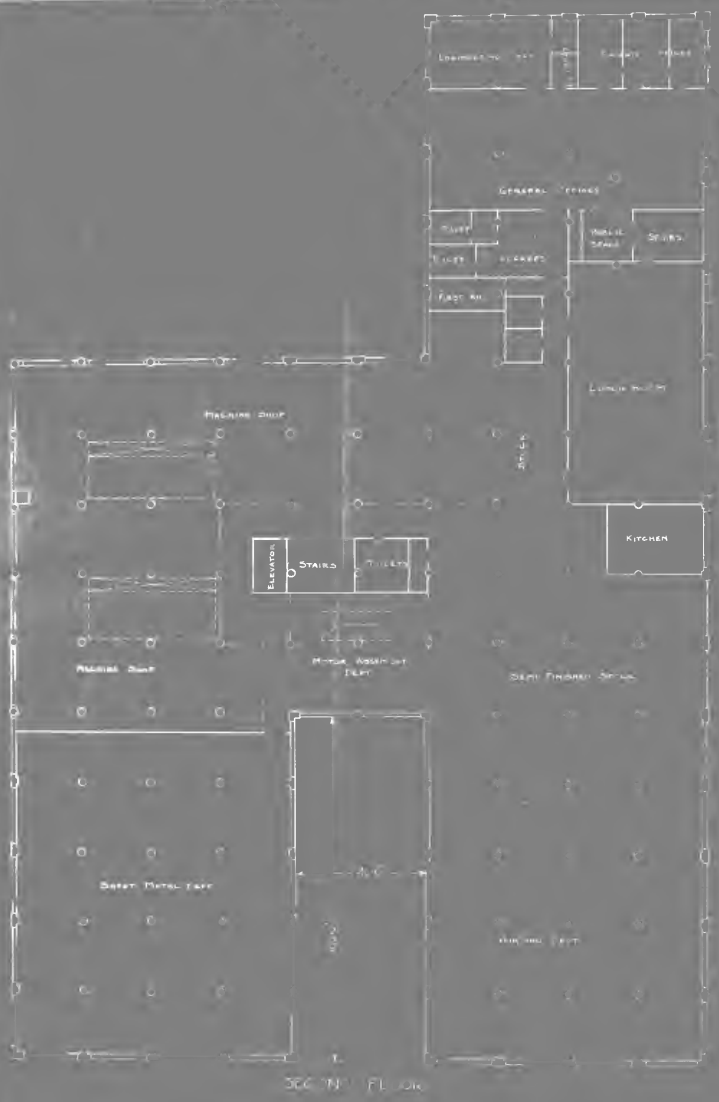
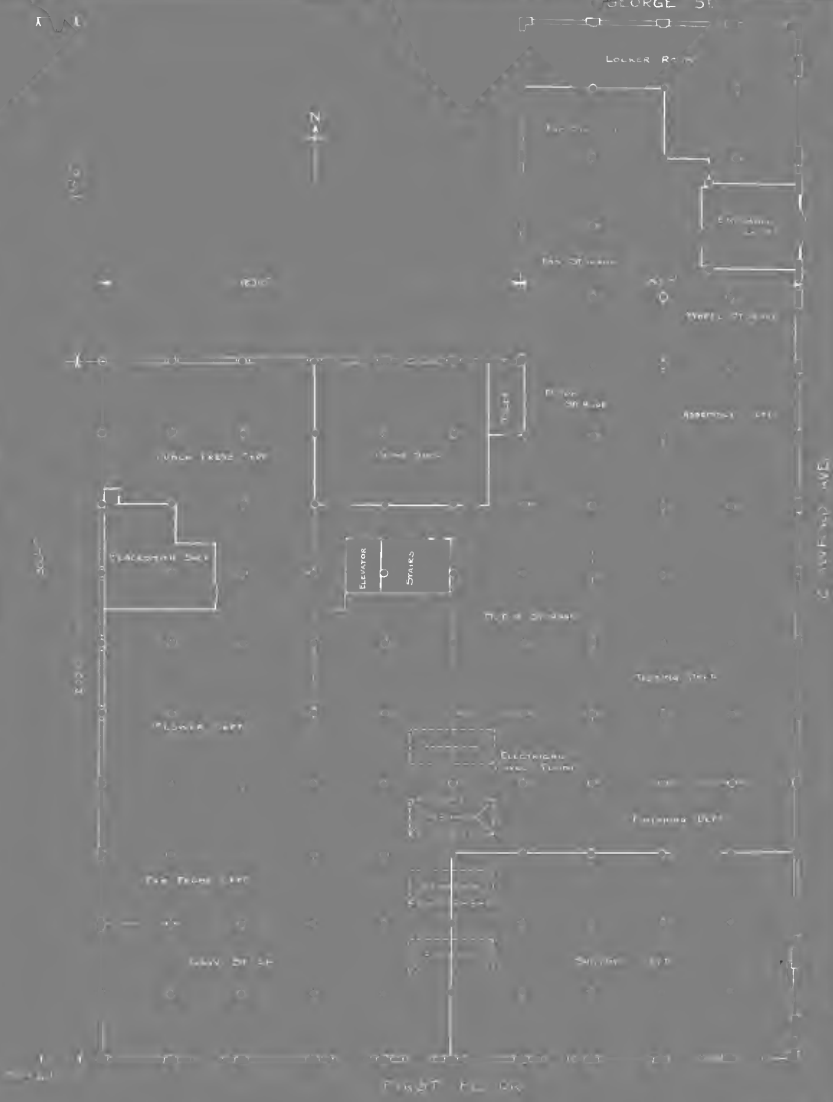
SECOND FLOOR

FIRST FLOOR

Exhibit No.8 shows a floor plan together with the overall dimensions of the building as it is actually being built. The photograph immediately proceeding the exhibits gives a birdseye drawing of the building. This building calls for a first floor area of 48,000 sq.ft. and a second floor area of 42,000 sq.ft. The area of the two extra floors in the tower is 560 sq.ft. each. In the top of the tower is located a 60,000 gallon sprinkler tank. The tank is carried on a concrete floor which frames into the concrete columns at a point 73 feet above the sidewalk. The tank which is of steel construction is to be set on cement grout so as to bring it to an even bearing.
